# NATIONAL BUREAU OF STANDARDS REPORT

AN INTERIM REPORT ON BOILING TESTS  
OF  
INSULATIONS FOR UNDERGROUND HEAT DISTRIBUTION SYSTEMS

1003-20-4881

October 28, 1958

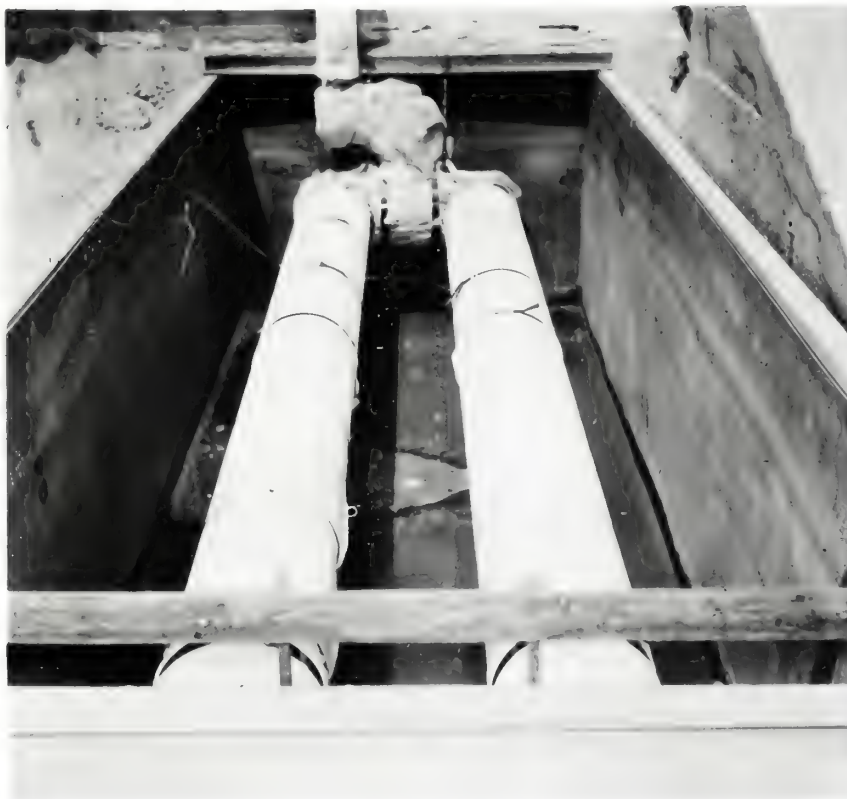
Figure 1

Reference to photographs: Fig 1 shows initial appearance; right  
specimen.  
Fig 3 shows 1st section gone after  
72 hours; right specimen.  
Swelled appearance of 2nd section is  
primarily the stretched fabric covering.

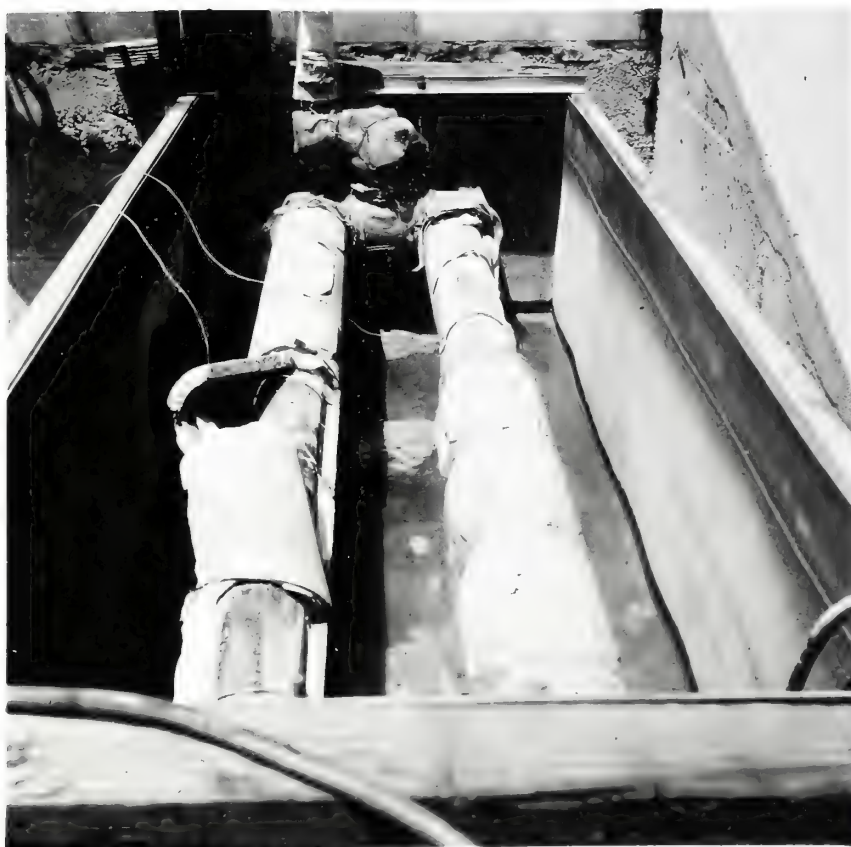
Figure 3

Cracks and ruptures: Insulation cut by wires on 2nd section and broken into pieces. Top half of 2nd section dislocated. See Fig 3; left specimen.

Reference to photographs: Fig 1 shows initial appearance; left specimen.  
Fig 3 shows rupture of 2nd section as it appeared after 72 hr of boiling; left specimen.

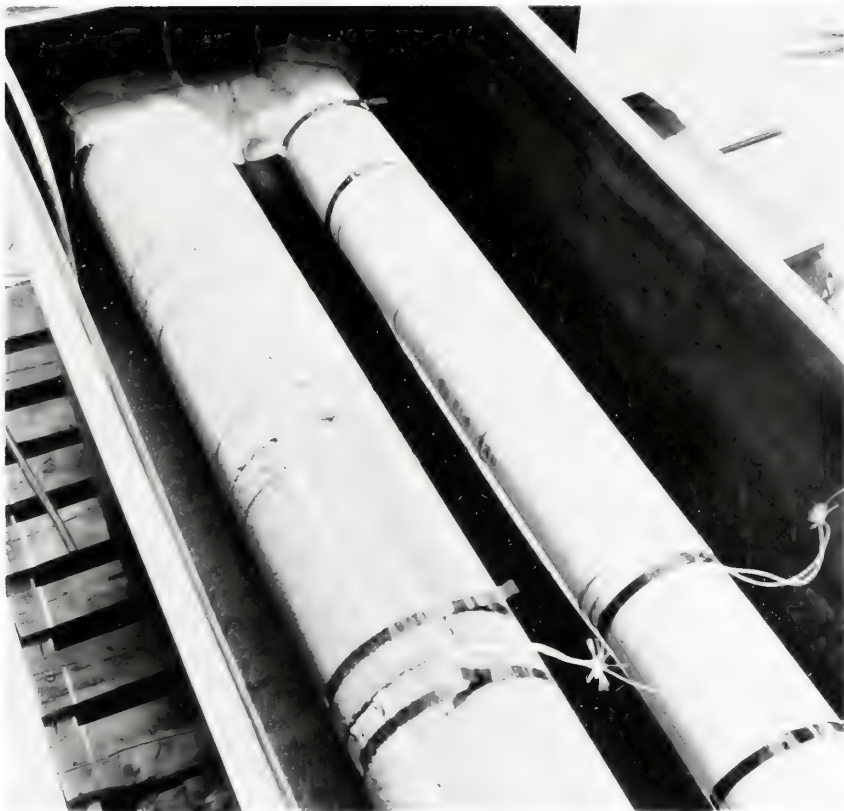
Figure 2

Reference to photographs: Fig 2 shows initial appearance; left specimen.  
Fig 4 shows appearance after 72 hr boiling. Dislocation of 4th section from cutting by wires shown in left specimen.

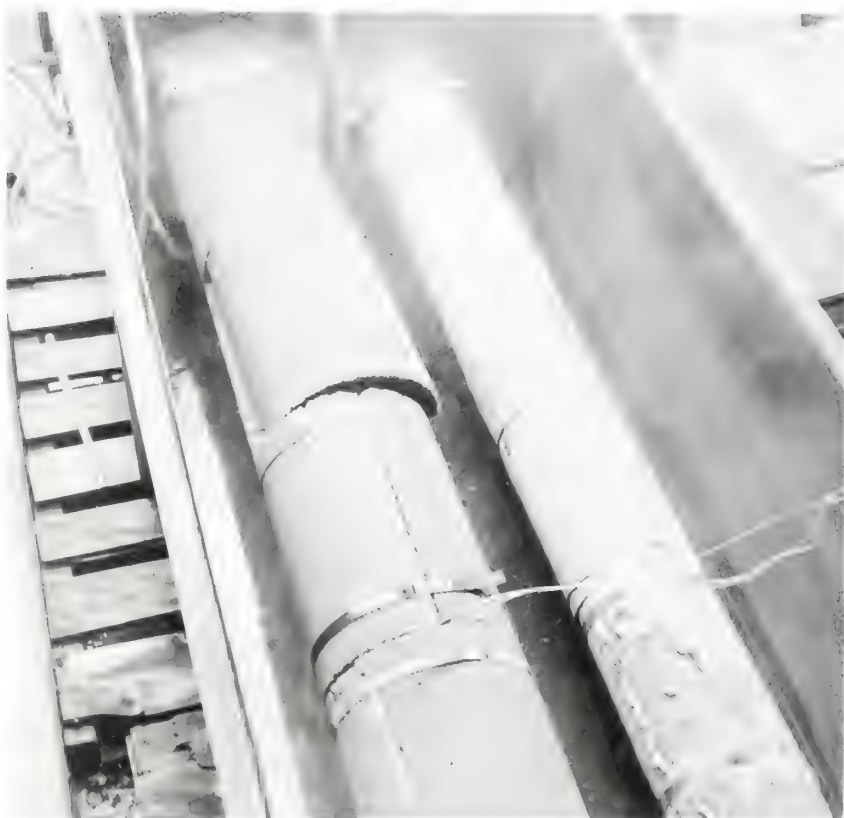
Figure 4

Cracks and ruptures: Vibration of fourth section caused wires to cut into insulation, but it was not severed. See Fig 4; left specimen.

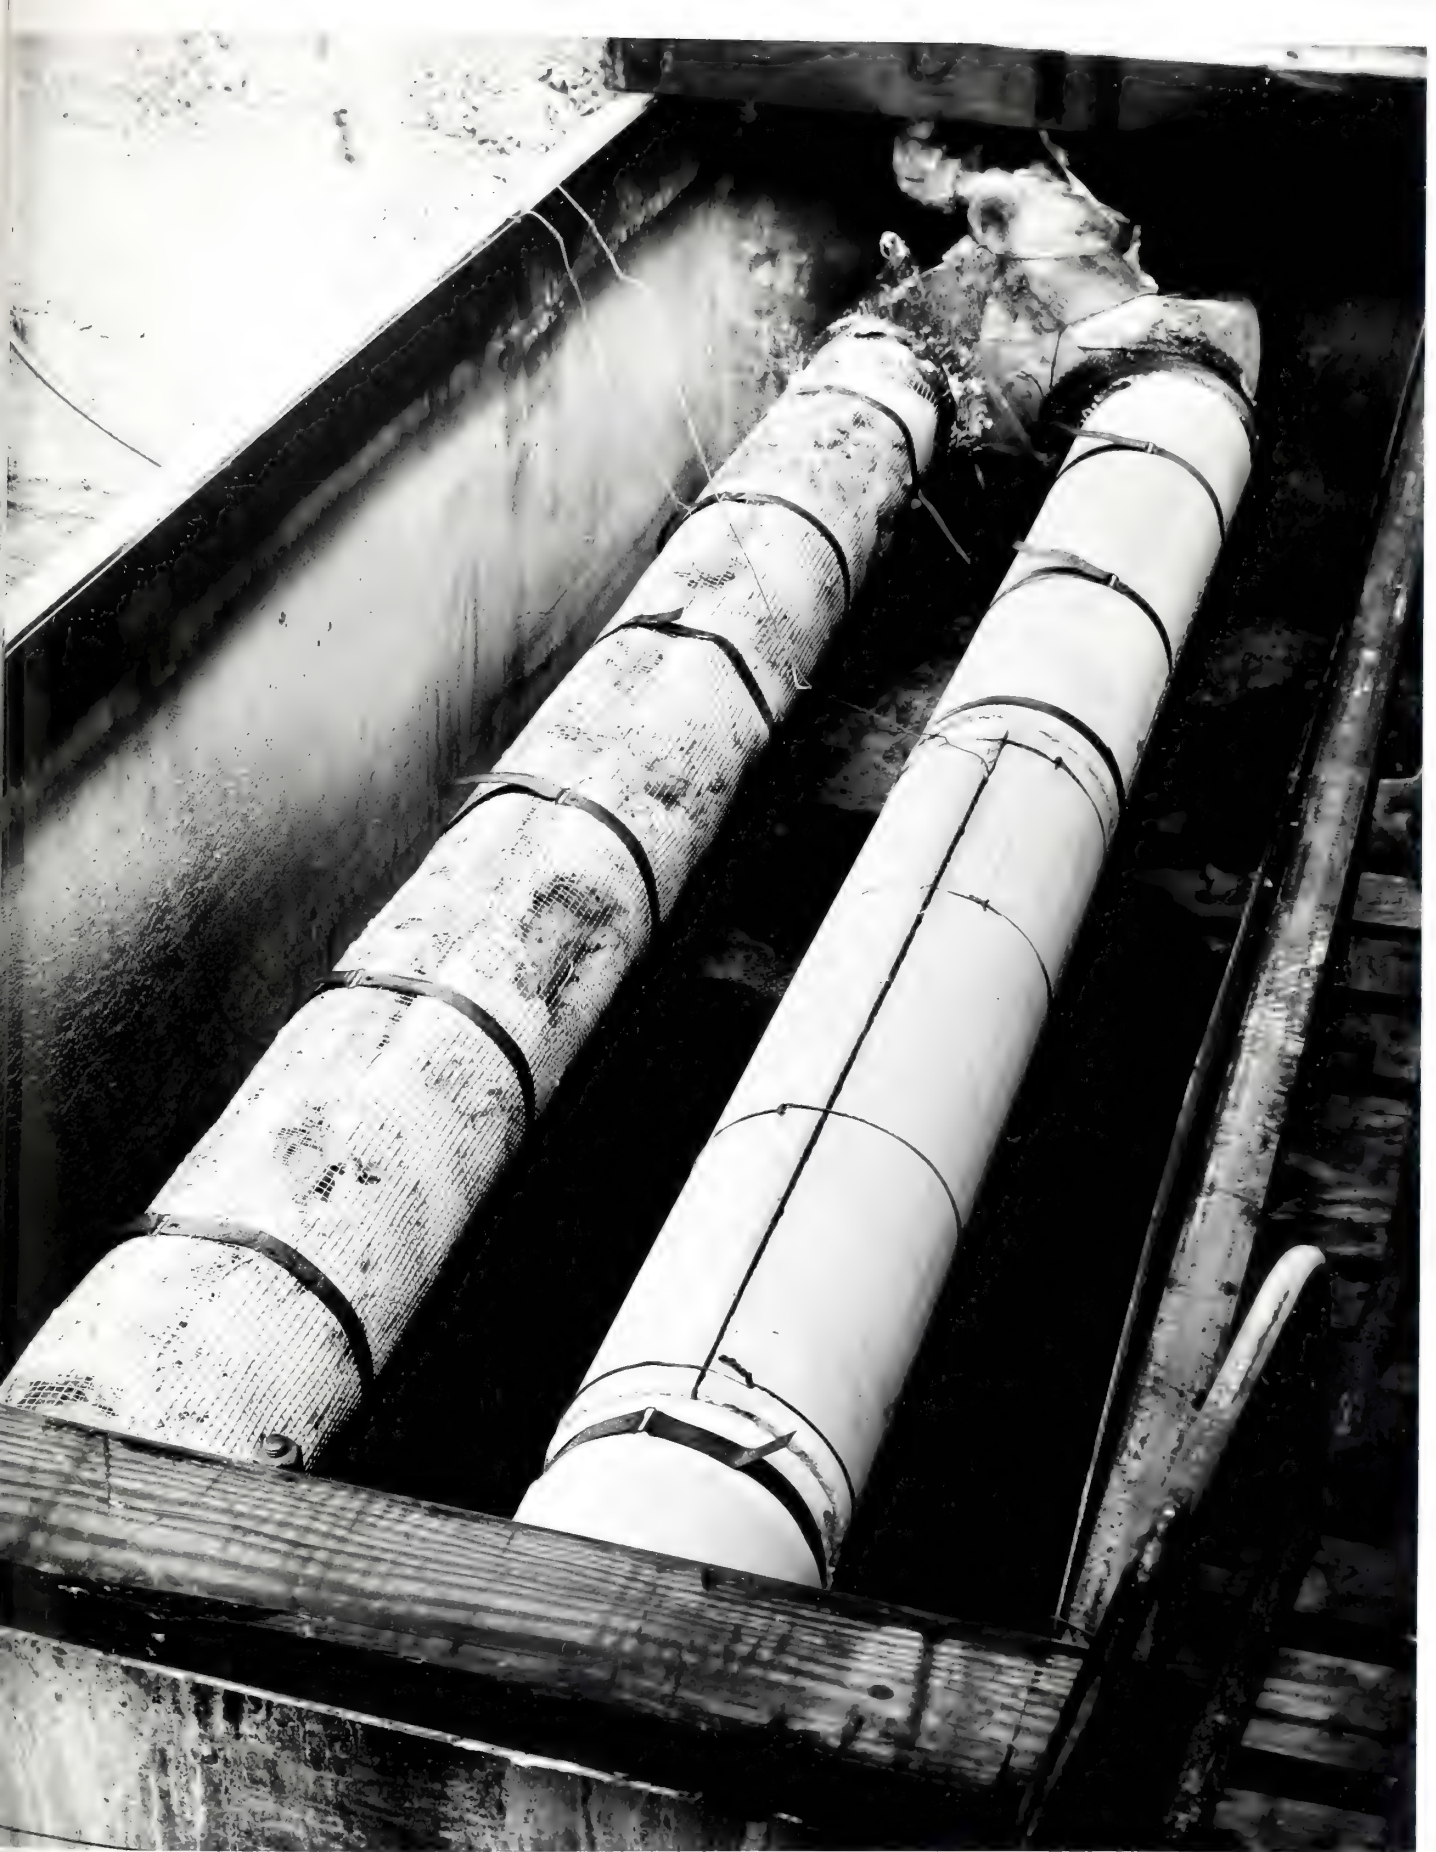
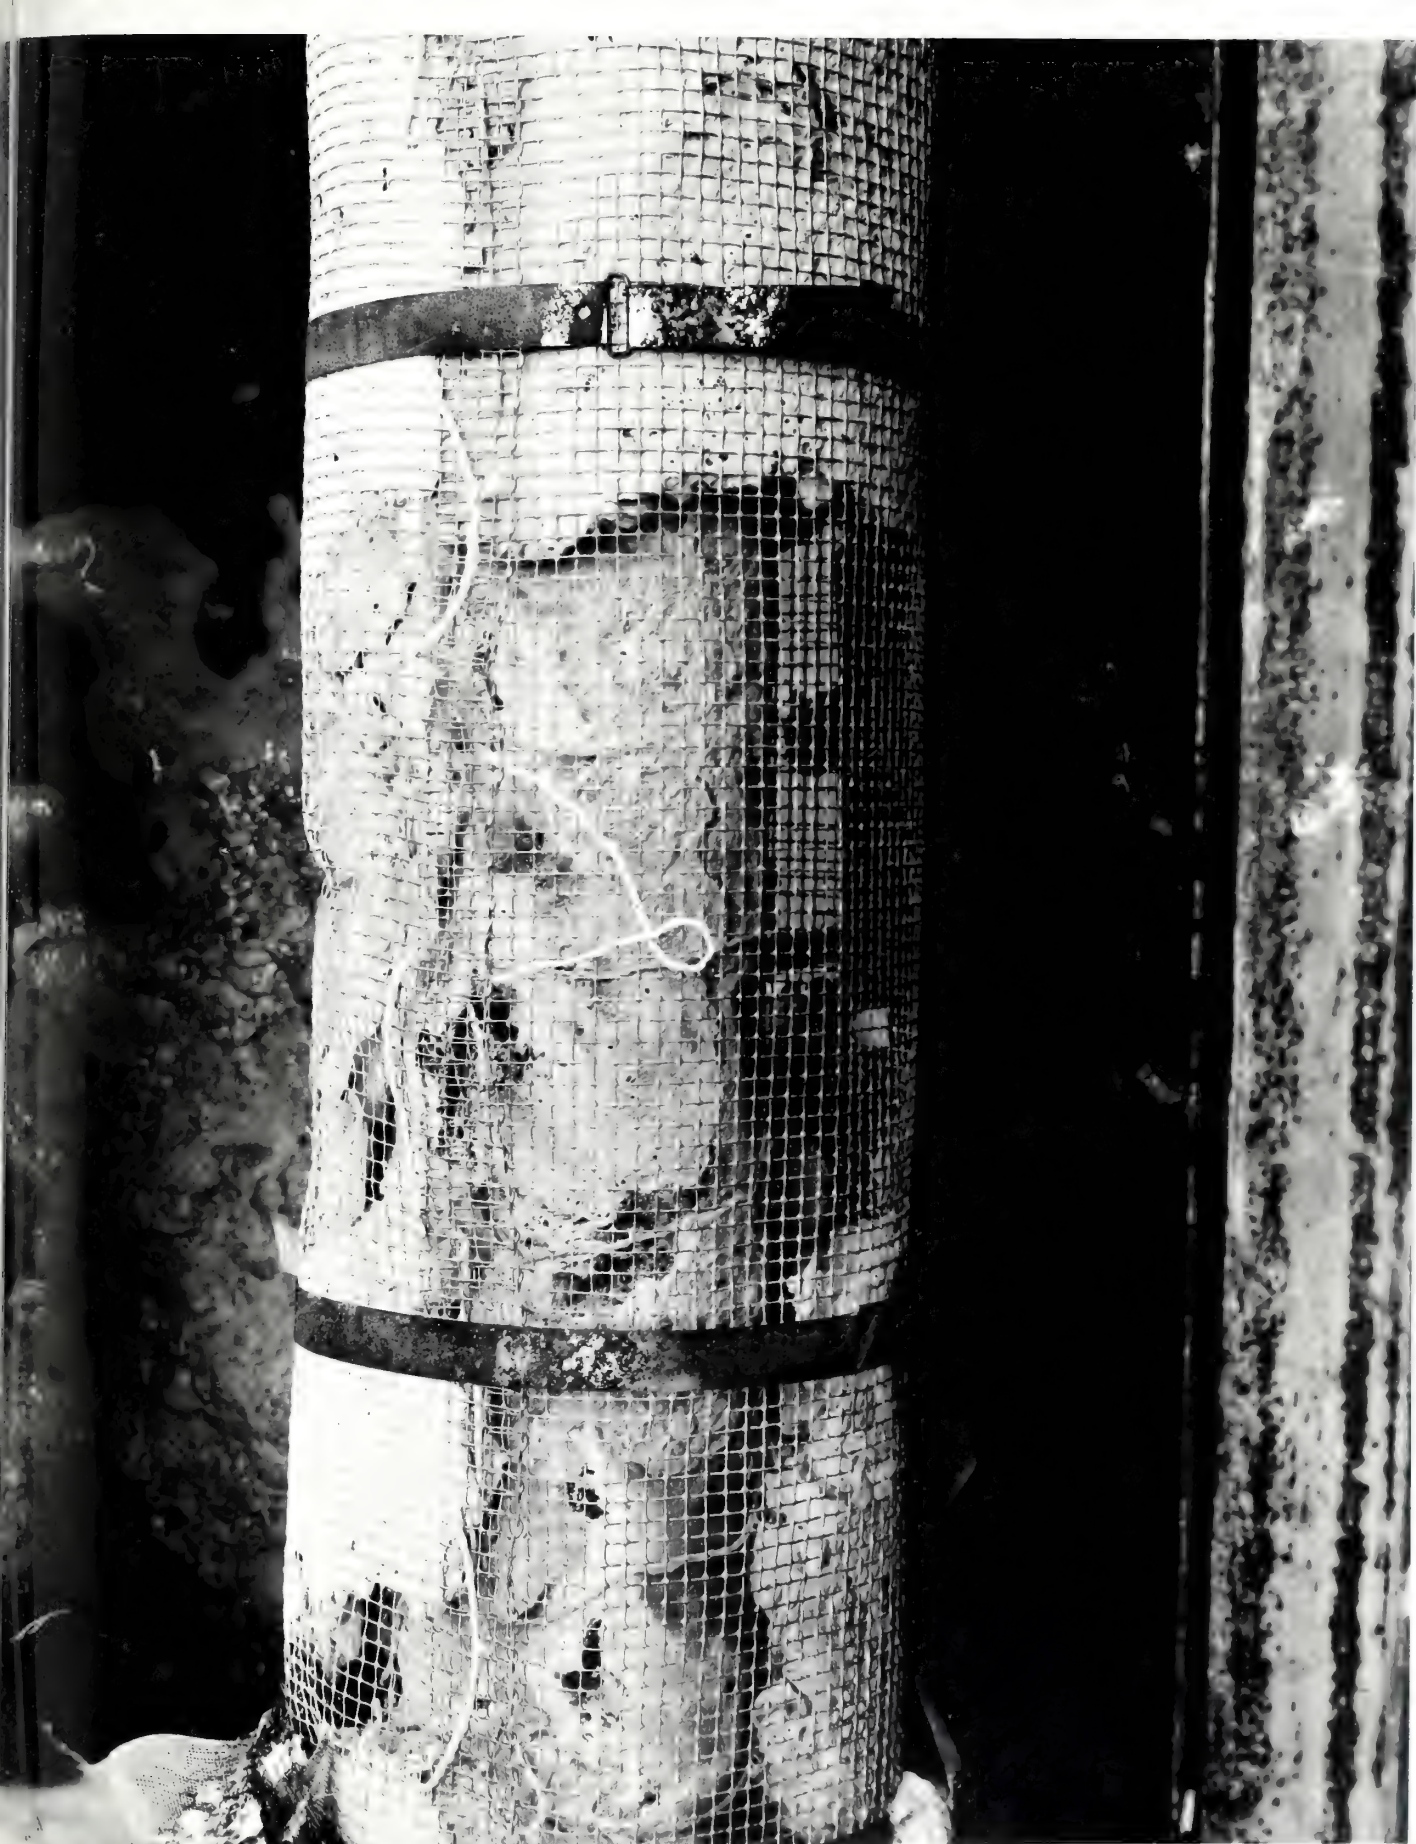
Method of fastening: A weighed amount of loose fill Fiberglas was spread as evenly as possible on a flat piece of 1/4 in. mesh hardware cloth and held in place with big stitches of cotton string. See Fig 8 and 9. Even though the insulation was spread as evenly as possible, there was an appearance of clumps in the layer and probable variations in density. The width of the mesh wrapper and the amount of insulation used was such that the insulation would be compressed to a density of 7lb/cu ft and a thickness of 1-1/2 in. when wrapped around the pipe with the wire mesh overlapping one inch at the edges. The wire mesh wrapper was held in place with 3/4 in. bands spaced 12 in. apart.

Other damage: 4 in. pipe exposed in many places as voids appeared in an irregular pattern in the insulation

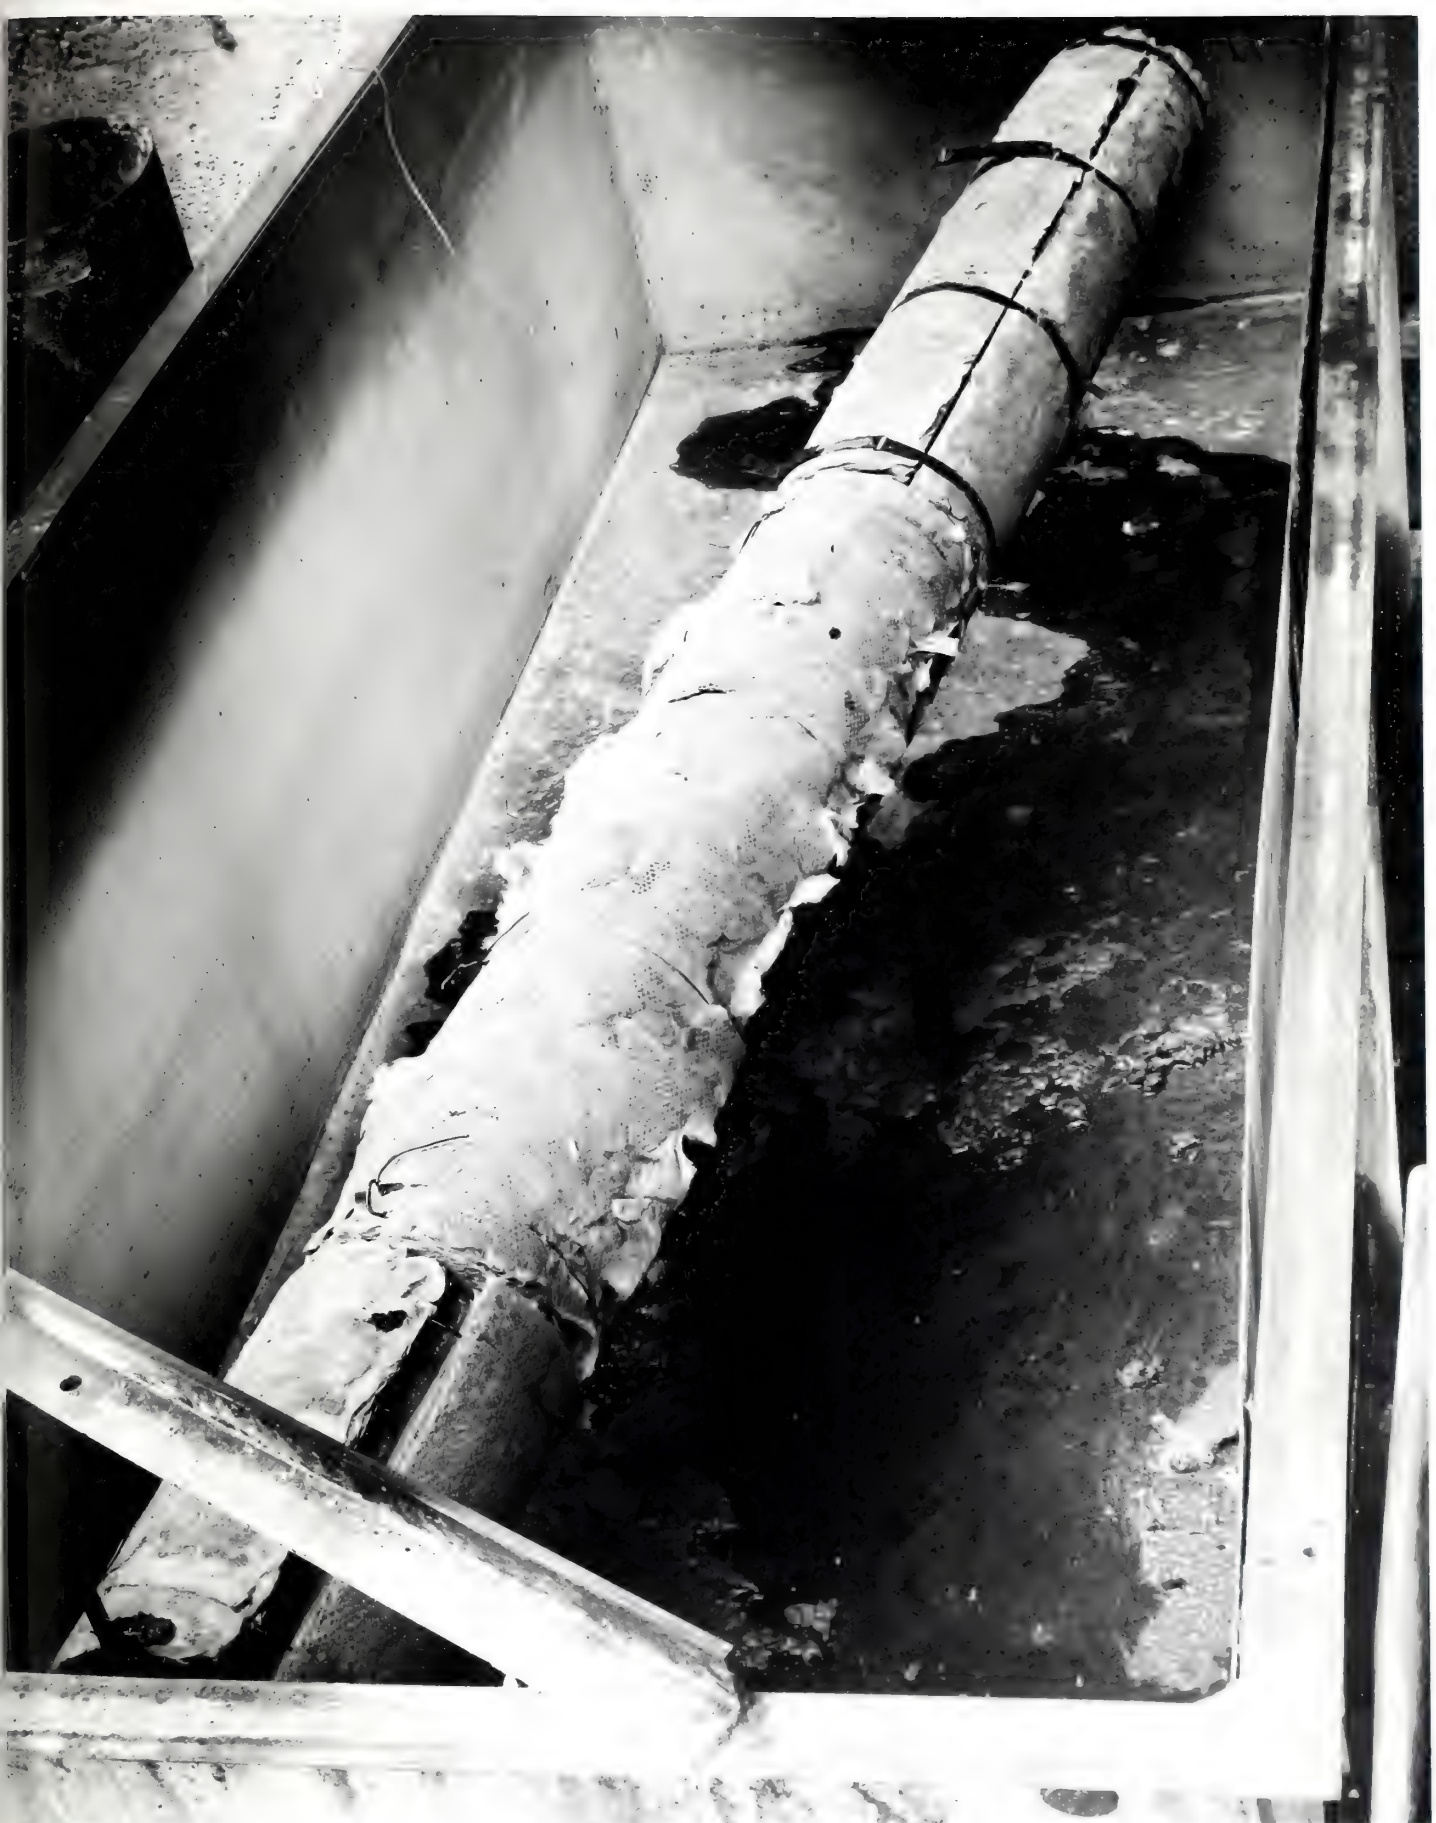
Figure 11

Cracks and ruptures: No cracks or complete ruptures but surface cut by wires

Other damage: Wires cut into insulation. See Fig 12

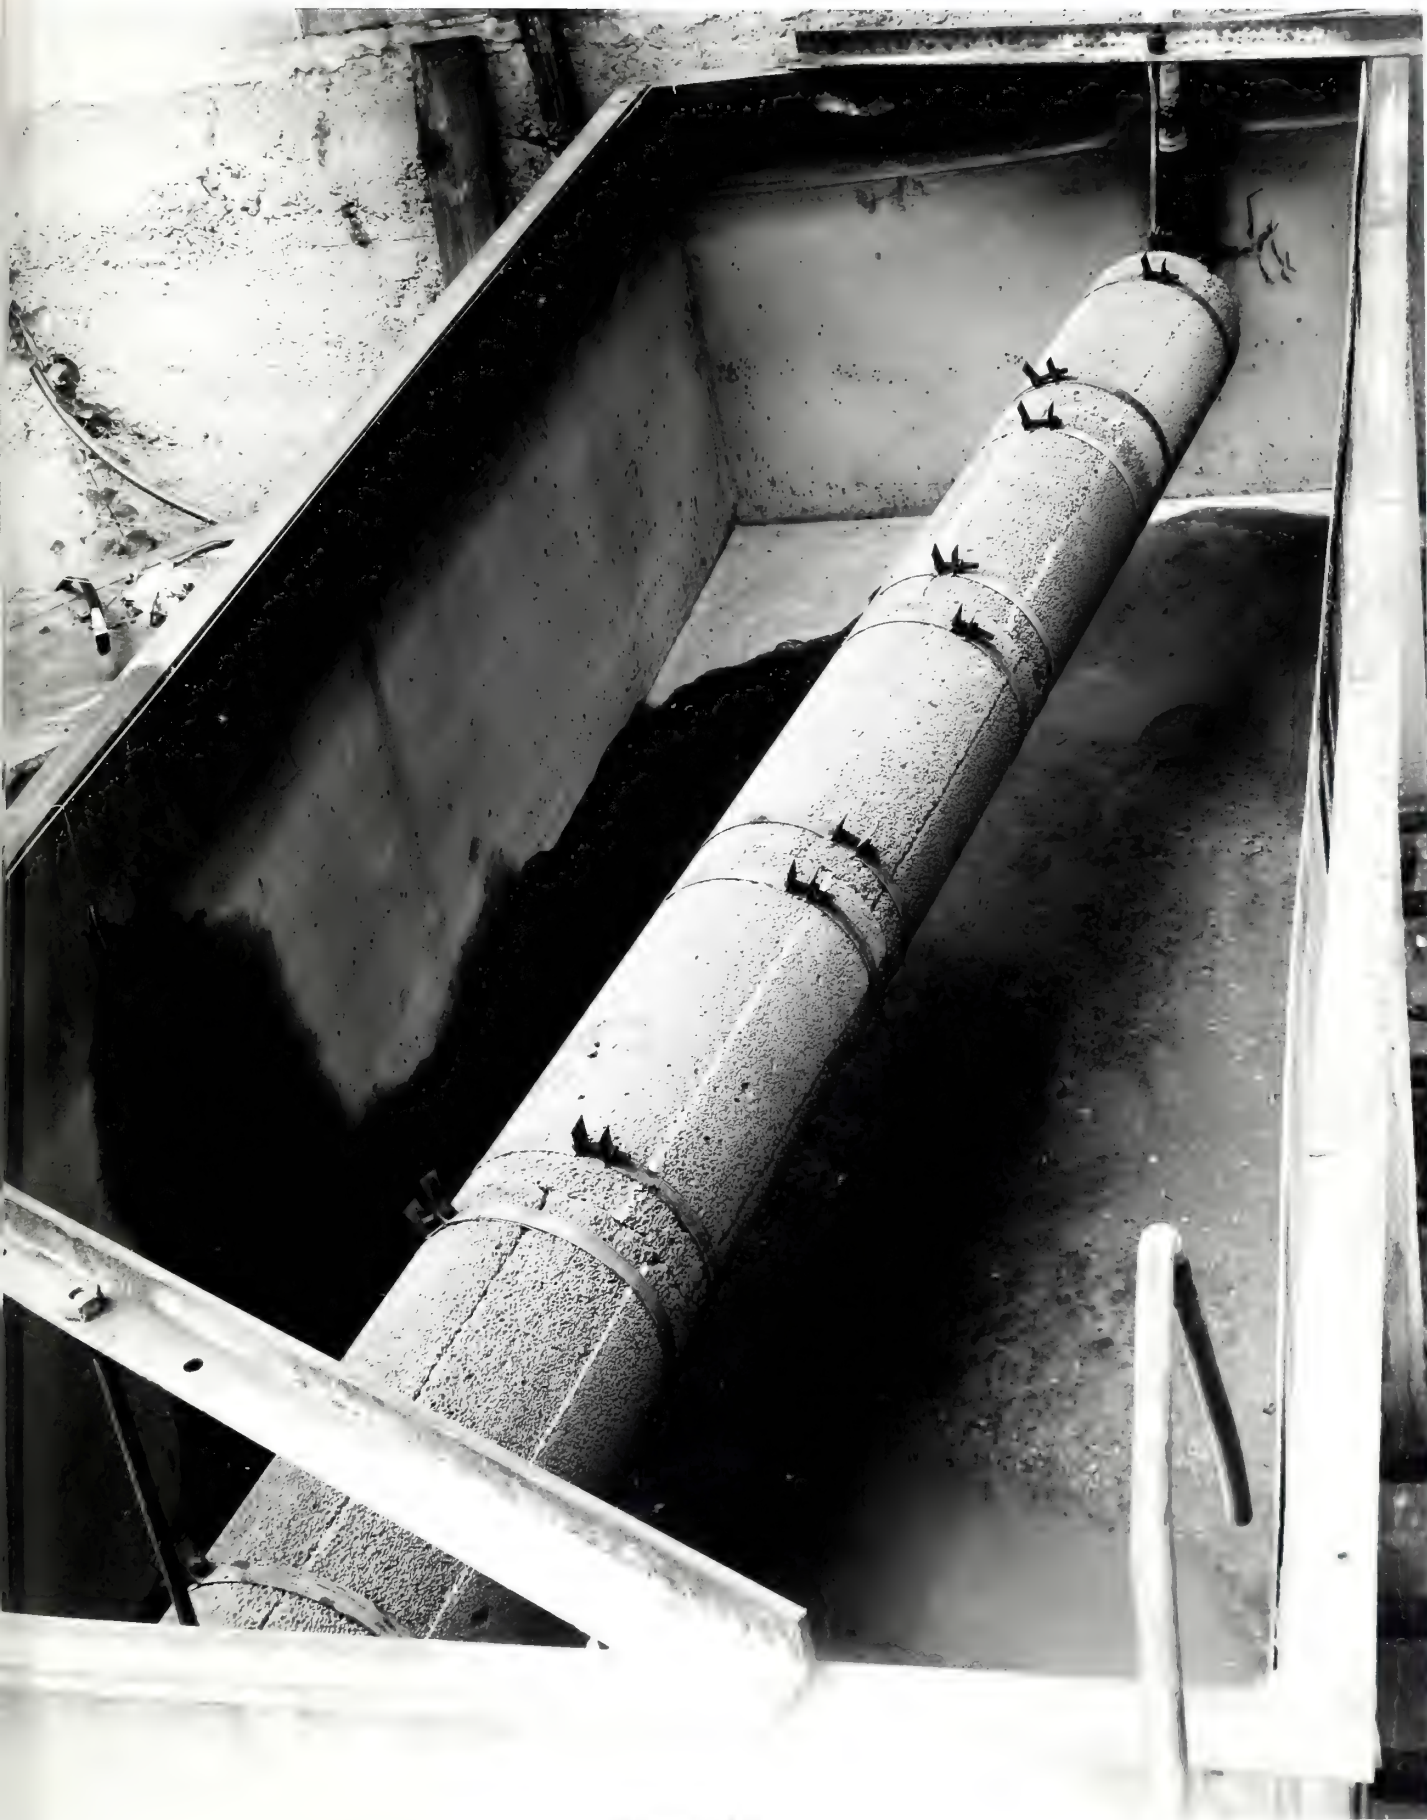
Figure 13

Cracks and ruptures: About half of the individual pieces cracked circumferentially when steam was first turned on. No additional cracks developed during the test.

Other damage: Sections cracked on initial heating but cracks had not changed after 144 hrs. Cracks may have been caused by tight banding and pipe expansion on heating.

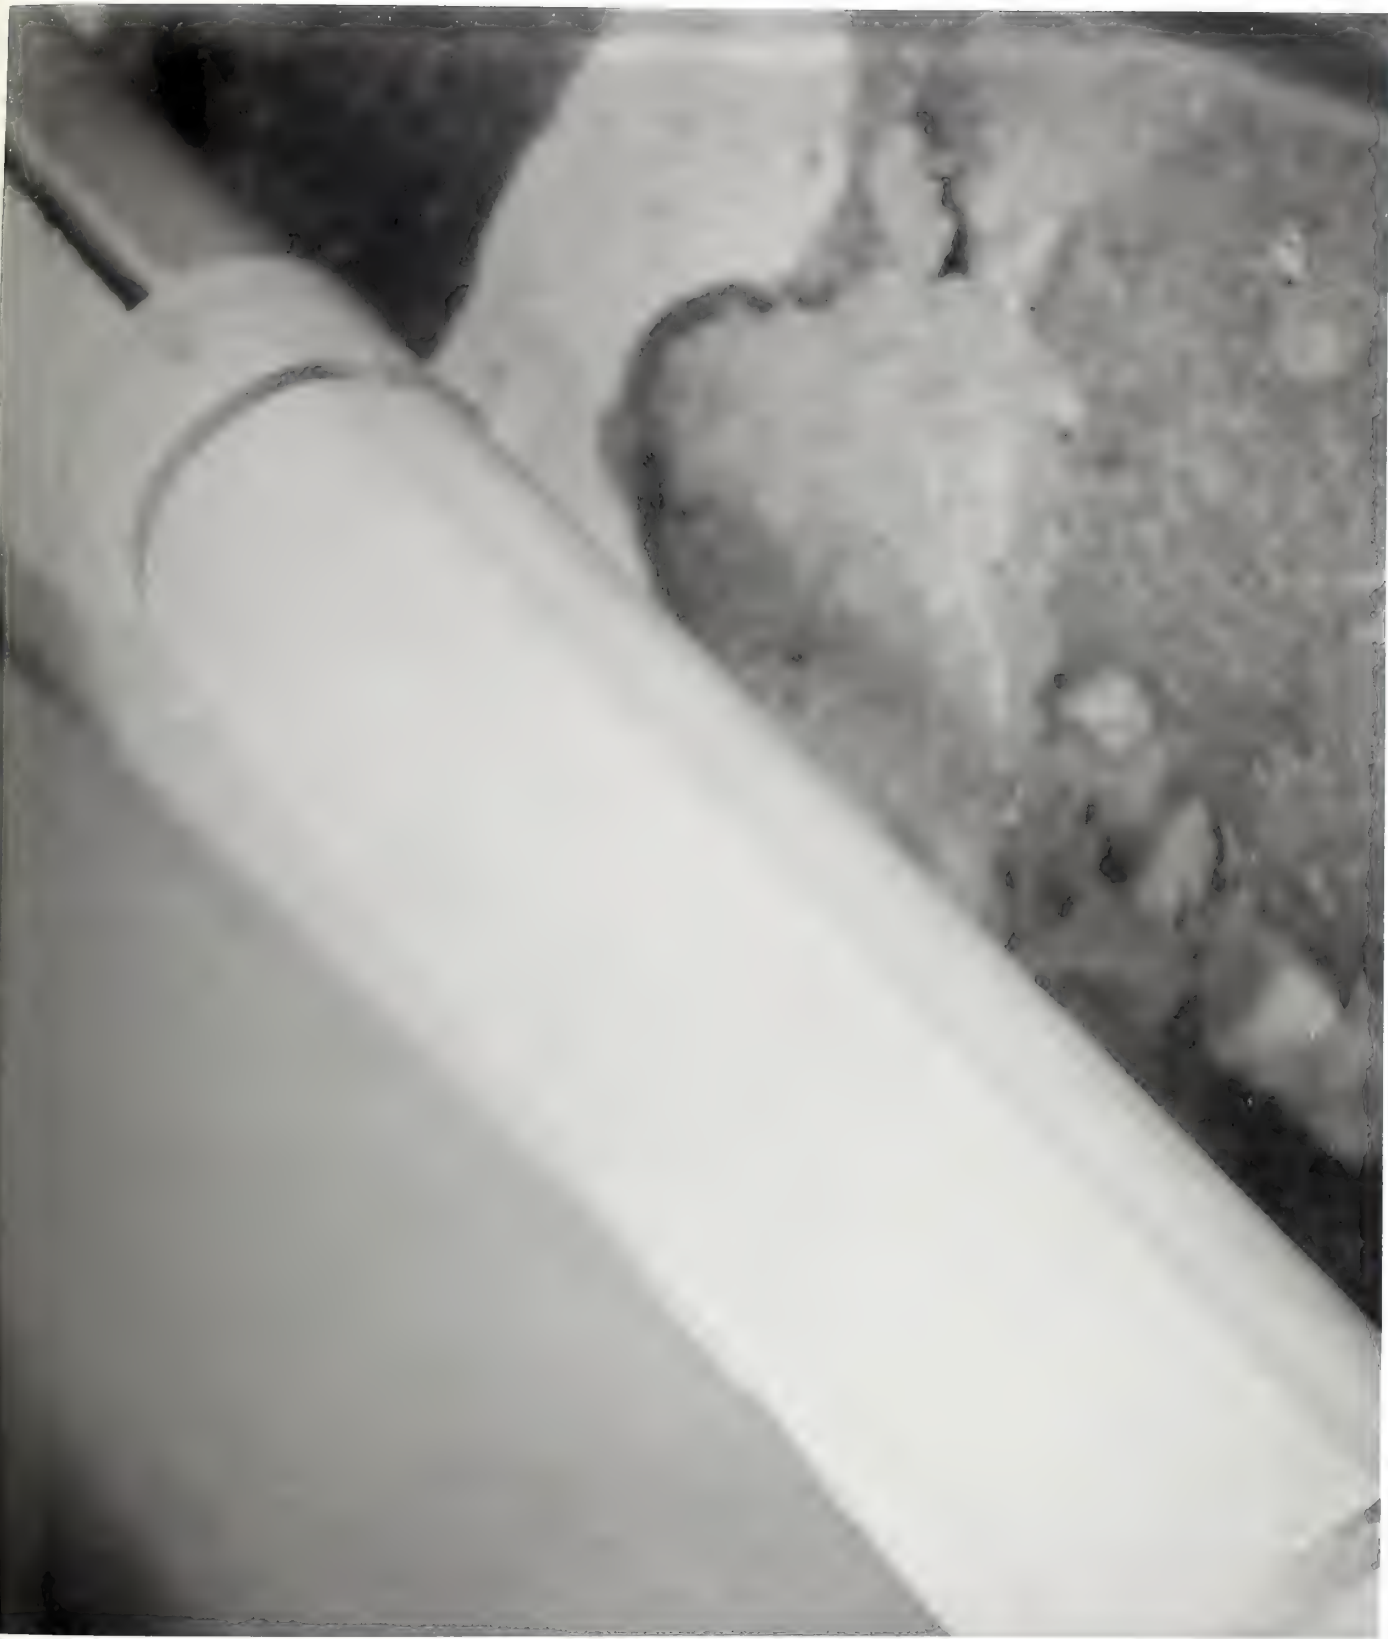
Figure 14

Amount fallen from pipe: 1st section fell off in less than 24 hrs when aluminum straps sheared.  
1st section replaced and steel straps used.  
1st section off again after 48 hours boiling. Replaced and boiled for an additional 72 hours with one piece breaking off.

Cracks and ruptures: At 72 hours, seams of mesh-covered sections had opened about 2 in. 2 straps were added to the second section and after 72 hours of additional boiling, the seam opening had not increased in the second section but had in the short unstrapped section.

Other damage: Some erosion at joints after 144 hours of boiling.

Reference to photographs: Fig 14 shows condition of mesh-covered section after 144 hours of boiling.

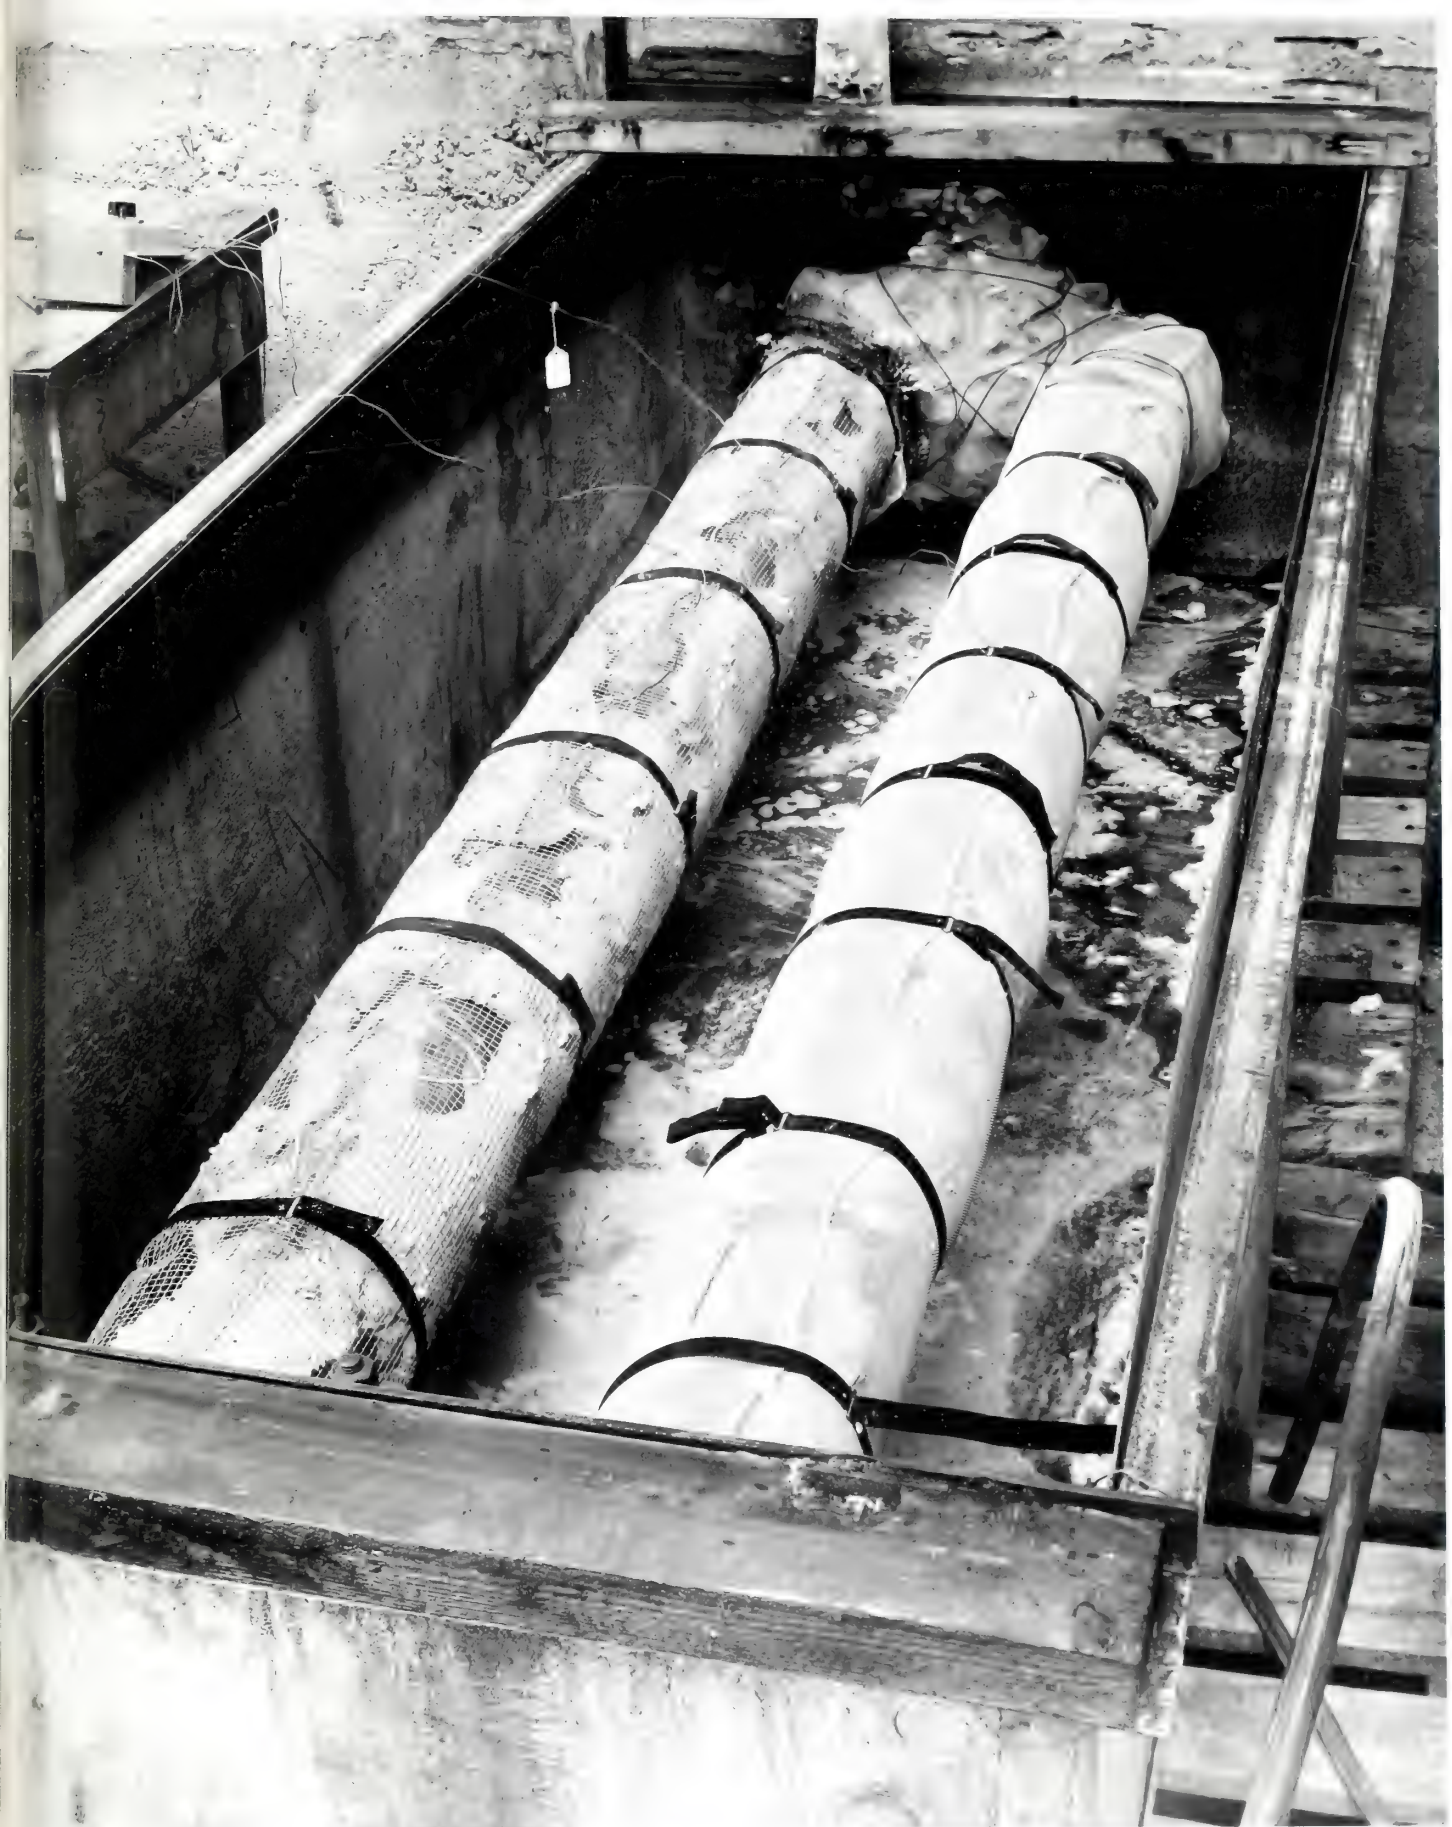
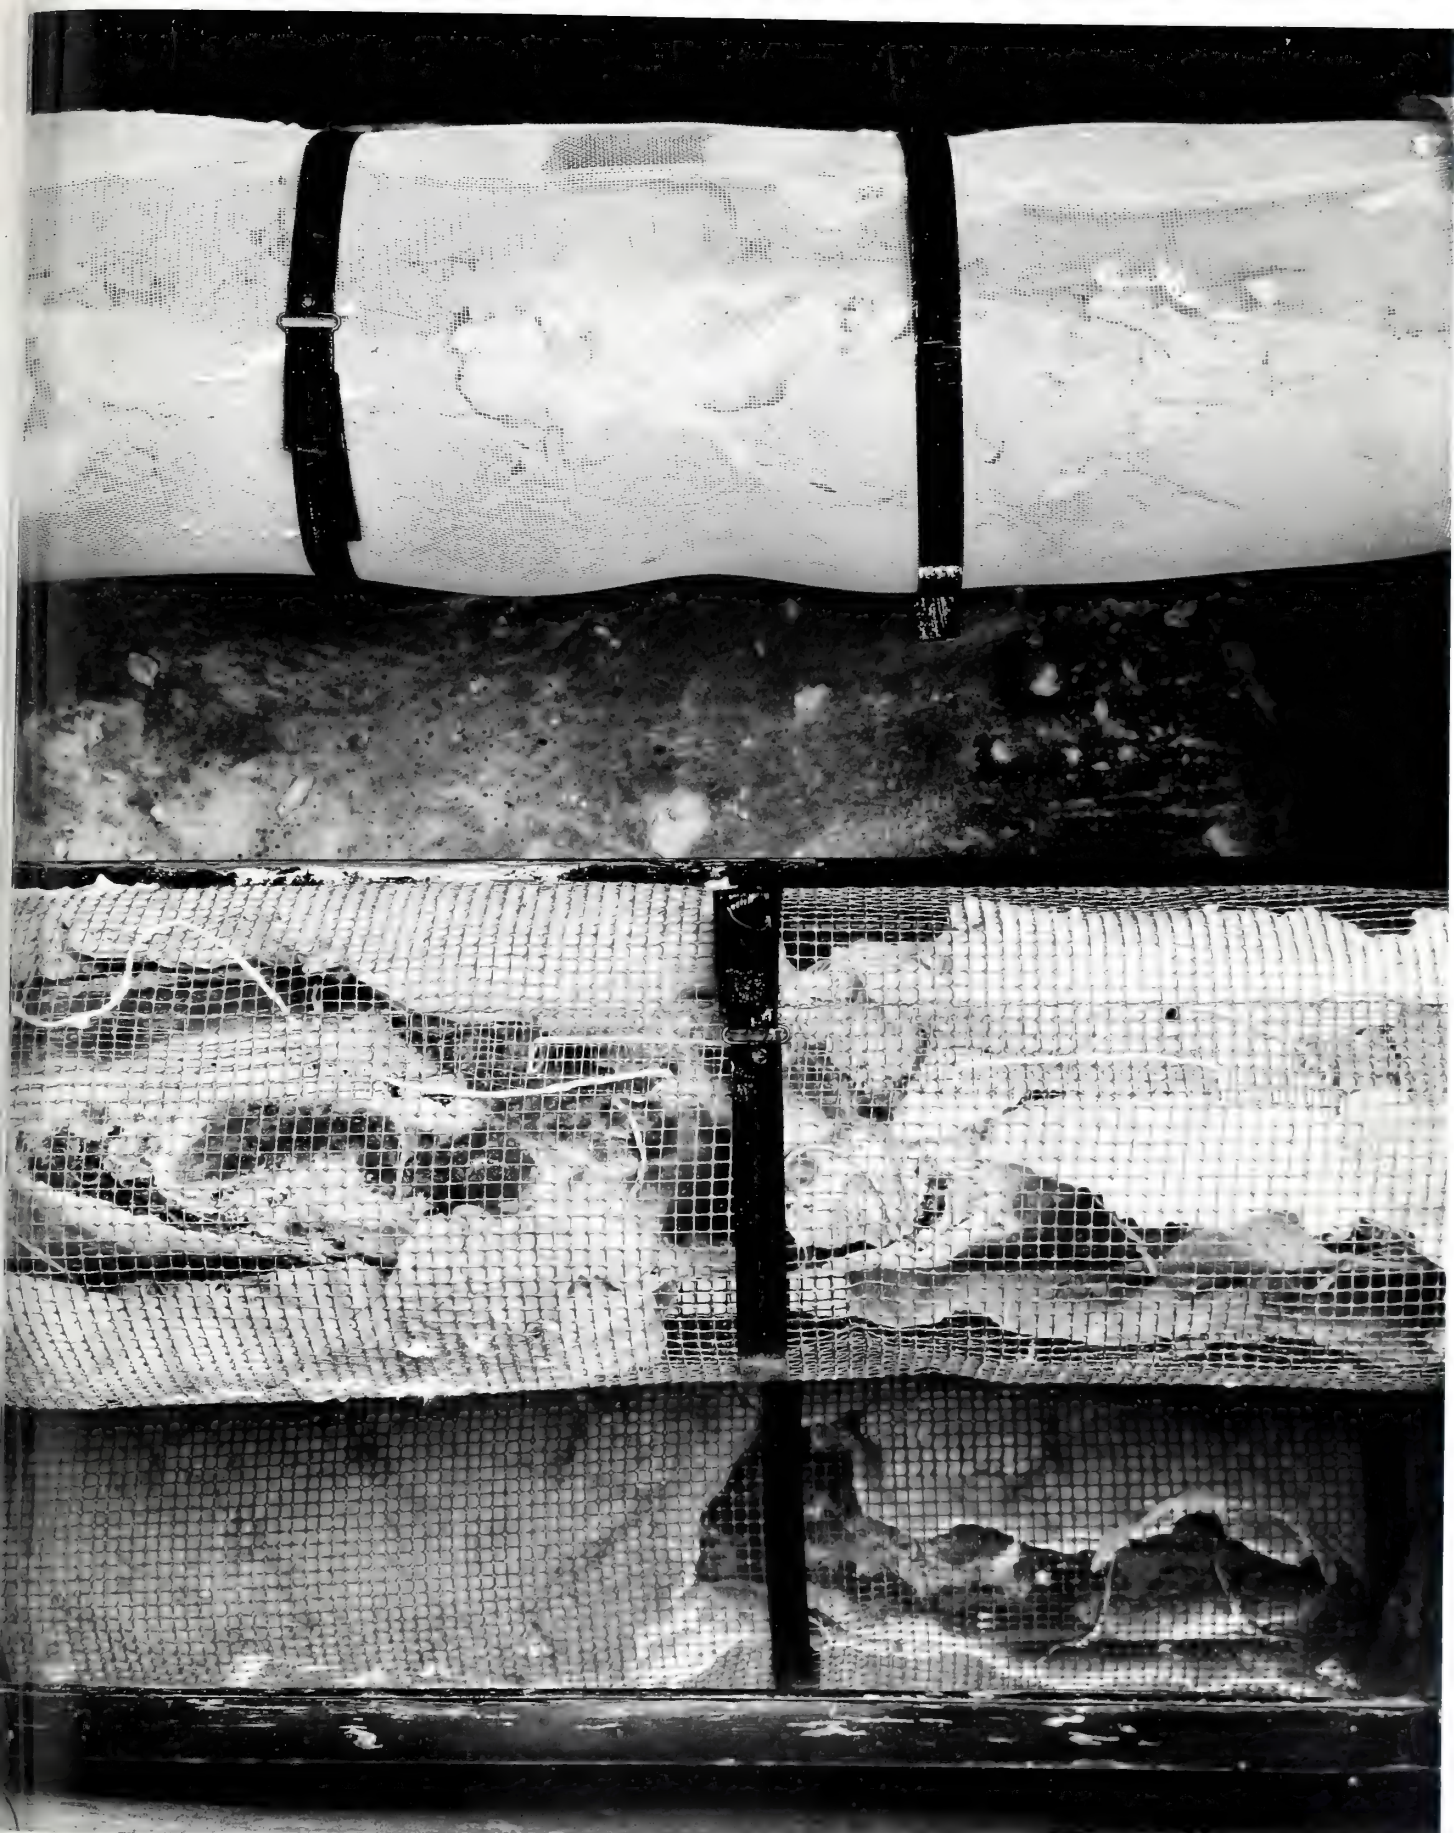
Method of fastenings: A weighed amount of loose fill Fiberglas was spread as evenly as possible on a flat piece of 1/4 in. mesh hardware cloth and held in place with big stitches of cotton string. See Fig 15 and 16. Even though the insulation was spread as evenly as possible, there was an appearance of clumps in the layer and probably variations in density. The width of the mesh wrapper and the amount of insulation used was such that the insulation would be compressed to a density of 7 lb/cu ft and a thickness of 1-1/2 in. when wrapped around the pipe with the wire mesh overlapping one inch at the edges. The wire mesh wrapper was held in place with 3/4 in. bands spaced 12 in. apart.

Other damage: Pipe exposed in many places as voids in an irregular pattern formed in the insulation.
